Safety Bulletin No 3

Safety and MEWPs: Incident at Milton Keynes

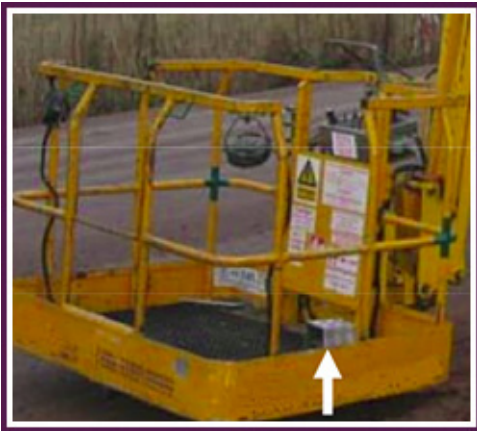
A serious incident occurred at Milton Keynes on 24 May 2008 where a member of staff working on an OLE gantry from a MEWP basket became trapped between the basket and the structure. This is the second incident involving trapping of the operator between a MEWP basket and a structure within the last six weeks.

Until the investigation is concluded, the following action must be taken with all MEWPs to help prevent any further incidents:

- As part of the pre-work checking of the machine, the positive operation of the 'dead man' control (usually a foot switch pedal) must be checked to ensure that the functional controls of the machine can be stopped in an emergency. If there is any doubt about the positive operation of this control, the vehicle must not be used until the MEWP's maintainer has passed the vehicle as being 'fit to be used' and that this is recorded and dated in the vehicle's log book.
- To avoid the risk of an entrapment situation occurring, the system of working to be followed requires that the basket is not to be raised directly under a structure, but off to one side of the structure, to a height just above the desired work height. The basket can then be lowered and manoeuvred towards/under the structure in full view of the operator by either slewing the basket or traveling the machine in creep drive
