FASET Bulletin APD03 (Revision 2) Upper Floor Access Hatches

Introduction

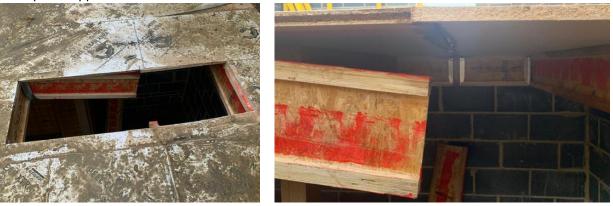
Another example of bad practice is show in the images below. A section of the floor has been removed without an Access Hatch in place and an inadequate temporary / sacrificial joist has been installed in an attempt to support the weakened floor.

FASET recommend that a designed Access Hatch is positioned 300mm off either wall in the corner of the floor.

When an Access Hatch is being positioned above Access Platform Decking (i.e. for the floor above), the Access Hatch should be positioned above a full panel and should not impede on a corner of any panel. This ensures that when Access Platform Decking is installed on subsequent floors the legs will not be positioned on top of the Access Hatch and therefore won't restrict the Access Hatches use.

- Any alterations to upper floors should be adequately designed by a competent Temporary Works Designer and signed off by the Temporary Works Coordinator prior to any access. This includes the provision of Access Hatches and temporary edge protection systems.

- The correct type of Access Hatch needs to be identified and then installed and used in accordance with the manufacturer's user instructions.
- Only designed and tested Access Hatches should be used
